## Abstract

## Improved Power board version 03 (with temperature monitoring)

## Special doubler capacitors for intensive flashing

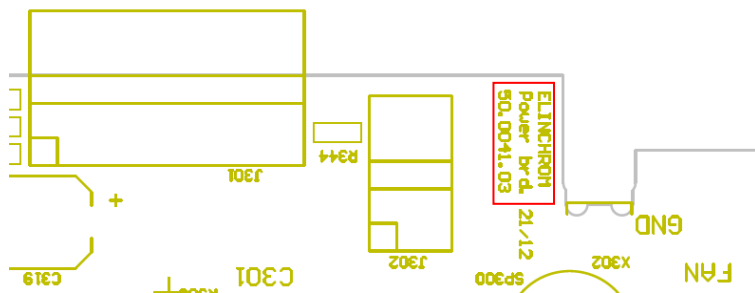
Starting from the serial No. below, the version 03 of the board 50.0041 has been introduced:

To recognize see the board marking

This version 03 of the board is provided as spare part (fully compatible with previous version).
