Flash Heads ELB 1200 – Tilt bracket defective		TECH-NOTE-023 Page 1/9	
Document.:	TECH-NOTE-023.docx		Rev.: 01		
Description:	Technical note for tilt head washer

Project:	ELB1200	Document No.:	10_00099		
Project No.:	10_00099	Revision :	01	Version :	1
		Elinchrom No. :	280.413

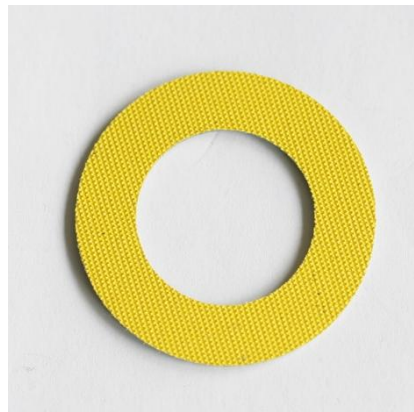
After field tests, photographers told us that, on some tilt brackets, the friction made by the washer of the tilt head was not enough to keep in position the head with big accessories (ex: very deep softbox). The material of this washer was the Habasit S-10/15.

Fig.1: Washer in Habasit S-10/15

A new material has been selected for the washer (Habasit MAM-04 H). It looks similar to Habasit S-10/15 (composite build with rubber and fiber) but is totally black color. Two washers are necessary per tilt head.

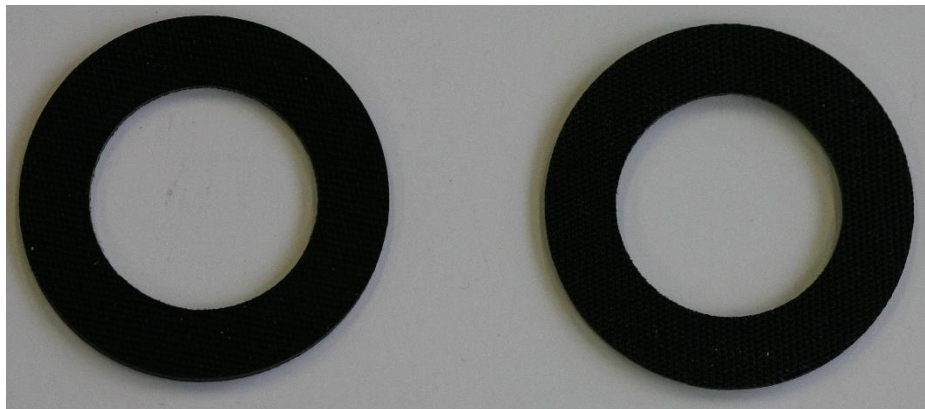
Fig.2: Bracket Washer 280.413

The new washer will increase the torque of the tilt head by almost 50% and his behaviour in a wet environment is improved. Moreover, this washer is better in term of visual aspect.
