Diodes D300, D301 and D302 short-circuited on the Powerboard Quadra

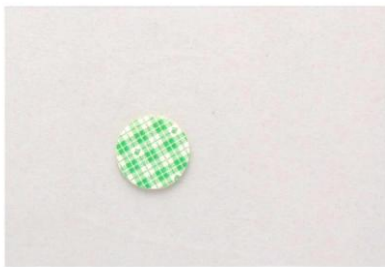
105.190 Diode UF5408 DO-201AP 3A/1000V

230.086 PCB Insulation RQ power board with adhesive washer

Replace Power board 230.056.ADJ or replace the 3 diodes (**105.190**) D300, D301 and D302 on the board.

Note: For replacing the three Diodes **105.190**, you need also to replace the PCB Insulation RQ power board with adhesive washer **230.086**
