Ref. : D.Job

Red Led 10% always ON

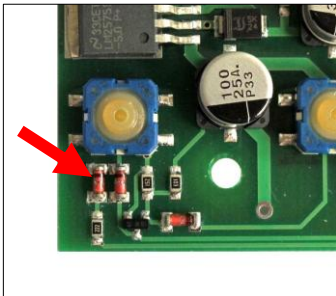
Even if the Ranger RX unit is OFF, the red Led 10% could stay ON.

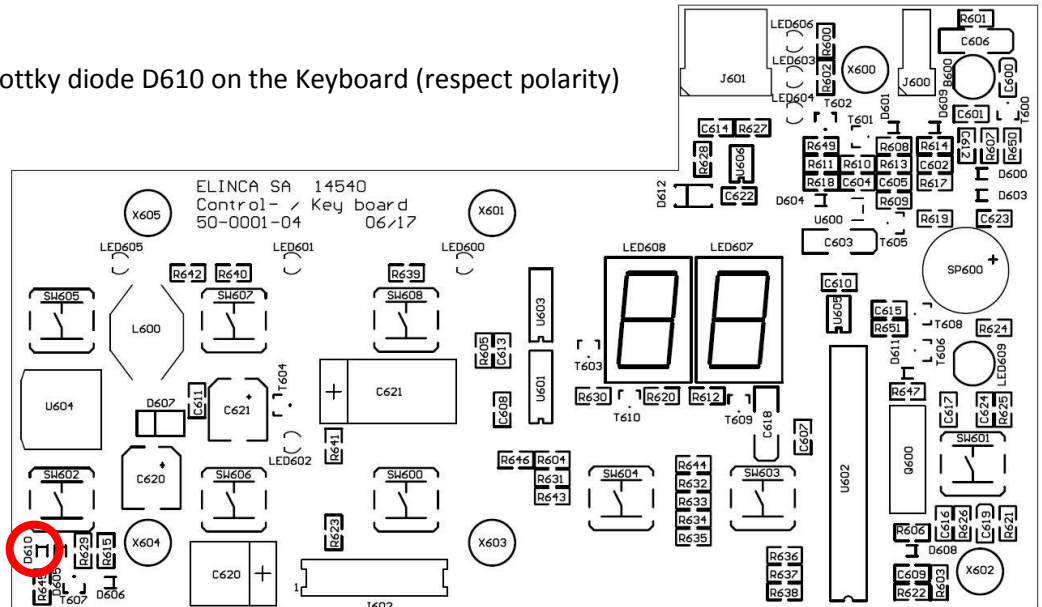
Diode to replace

Due to a defective Schottky diode, in some rare case, you can find this issue :

We suggest to replace the Schottky diode D610 on the Keyboard (respect polarity)

If you find this issue, please fill and send a warranty request form to obtain the replacement free of charge of the Diode Schottky 0.2A 30V TMMBAT42 **105.147**.
